SKF alignment solutions save money, cut downtime

SKF Shaft alignment tool: TMEA 2

SKF Belt alignment tool: TMEB 2

Shopping centre saves €41 256 by correcting fan-belt alignment

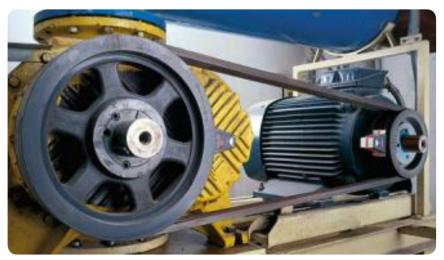
Shaft alignment is quick and easy with a high degree of accuracy.

3-step process: measure, align and document

Easy to attach: measuring units are attached to the shafts using magnetic brackets or chains

Accurate: each unit emits a precise laser line, projected on the detector of the other unit

Eliminates rechecking: display unit simultaneously provides clear, real-time coupling and feet values during the alignment process

Operator-friendly: display unit can be held in one hand, freeing the operator to perform alignment
